JULY 18, 2011 KEY FOR NUMBERED DOTS ON THE SCA HILLSIDE PARK MAP

Key for the Locations on the SCA Map showing omitted runoff control and erosion features

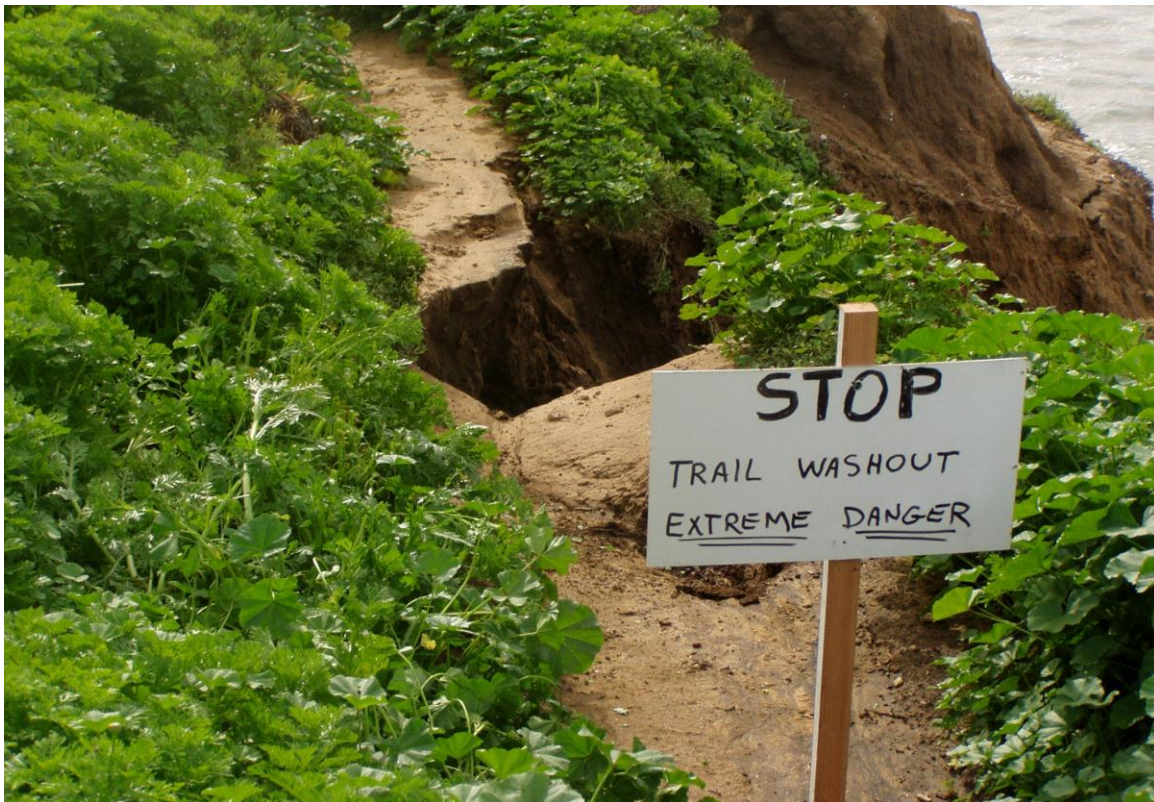
1. The erosion feature at Location 1 appeared just before this 2005 photograph was taken. Runoff from a major storm required the trail to be moved 5-10 feet away from the cliff edge, because it severed the main trail that ran along the cliff edge between Ladera Street and the northern end of Garbage Beach. The runoff that caused this erosion was mostly generated by the un-vegetated mound of soil left over from an abandoned construction project in the 1950s, which currently has an emergency telephone call box for reaching SD Lifeguards. This mound of soil and the compacted un-vegetated soil around it should be re-graded so it doesn't exacerbate this erosion feature in the future.

Figure 1. Erosion gully that in 2005 severed the main trail along the cliff from the Ladera and Sunset Cliffs corner to the Lower Parking Lot

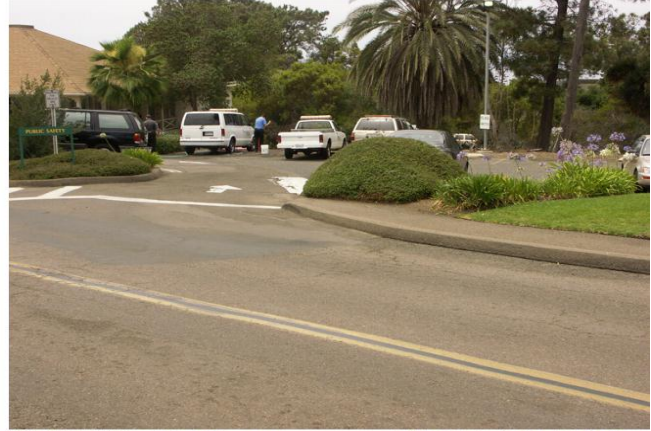
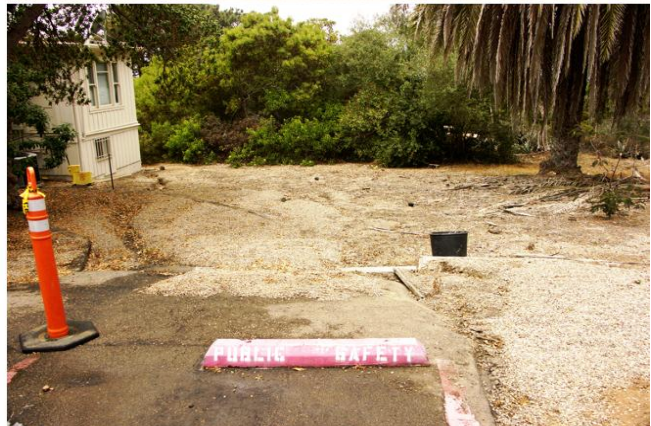
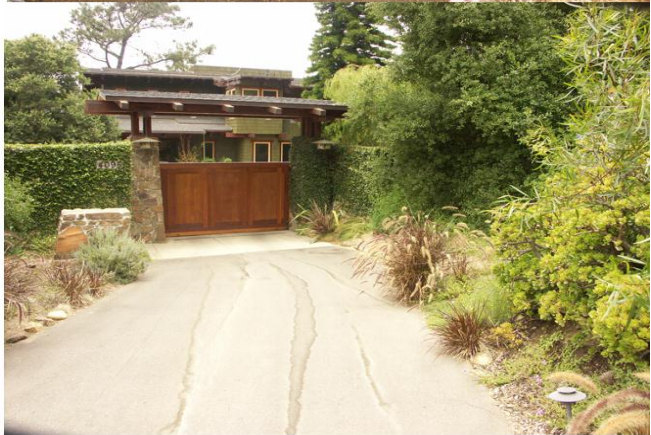
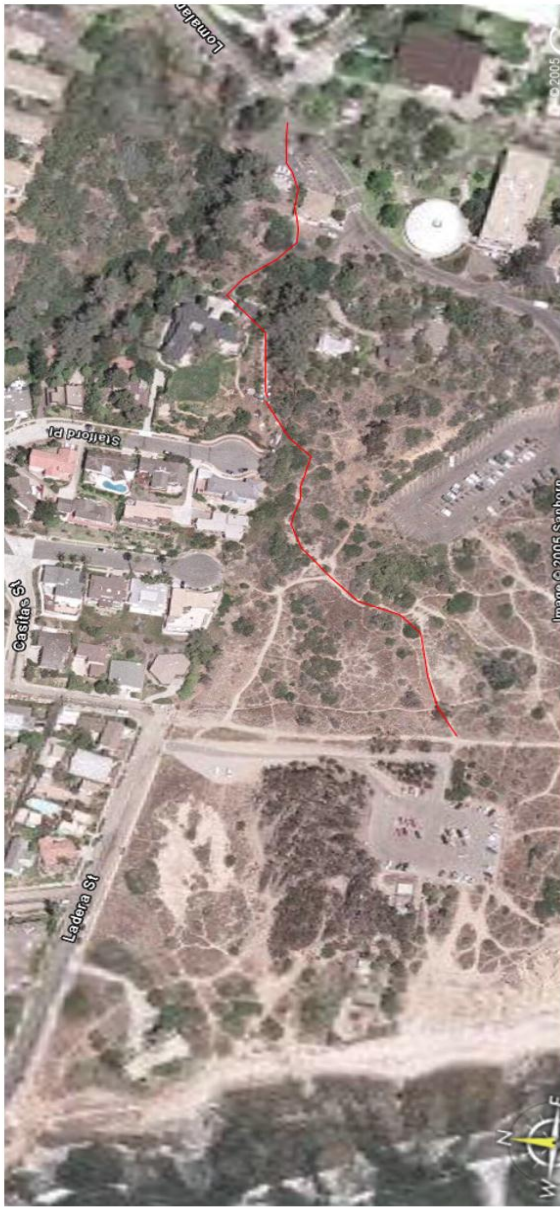
8. Runoff is generated near the PLNU Security Building and runs through private property before entering the northeast corner of the Hillside Park at A (see Figure 2) where it then flows down-slope until it reaches the area planned for the Multi-use trail. This runoff is a major cause of rill erosion along the area where the Multi-use trail runs, and methods to control it should be part of any comprehensive drainage plan for the Hillside Park. Until runoff in the northeast section of the Hillside Park is controlled, runoff will continue to flow southward along the Multi-use trail to a low spot where it exits to flow to the Lower Parking Lot. The location of the large puddle and erosion rills (shown in Figure 3) is where the runoff flows towards the Lower Parking Lot.

Figure 2. Watercourse at Location 8 runs from the PLNU Public Security Building, and through private property before discharging onto into the northeast corner of the Hillside Park near Stafford Place at A.

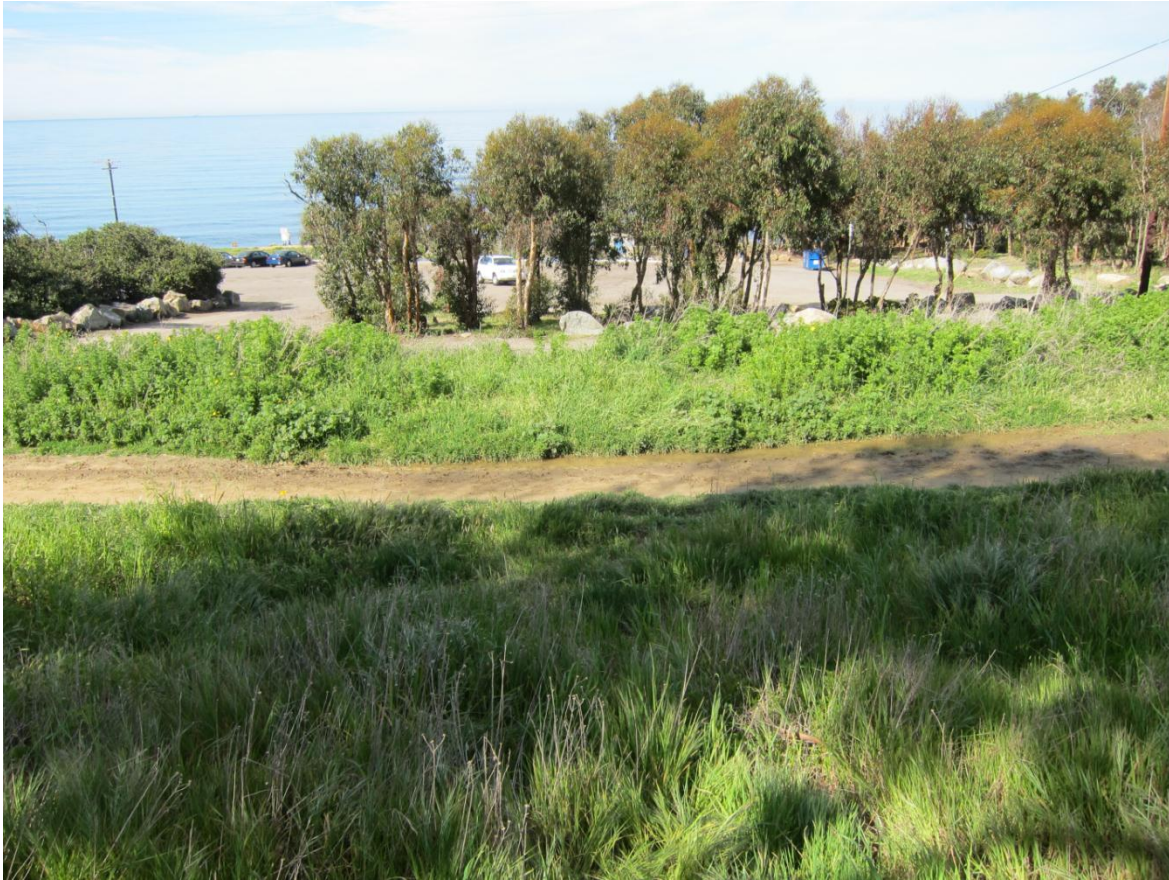
Figure 3. Runoff from Location 8, where runoff causes erosion rills along the trail, can form a large puddle where the runoff then flows down-slope to the Lower Parking Lot.

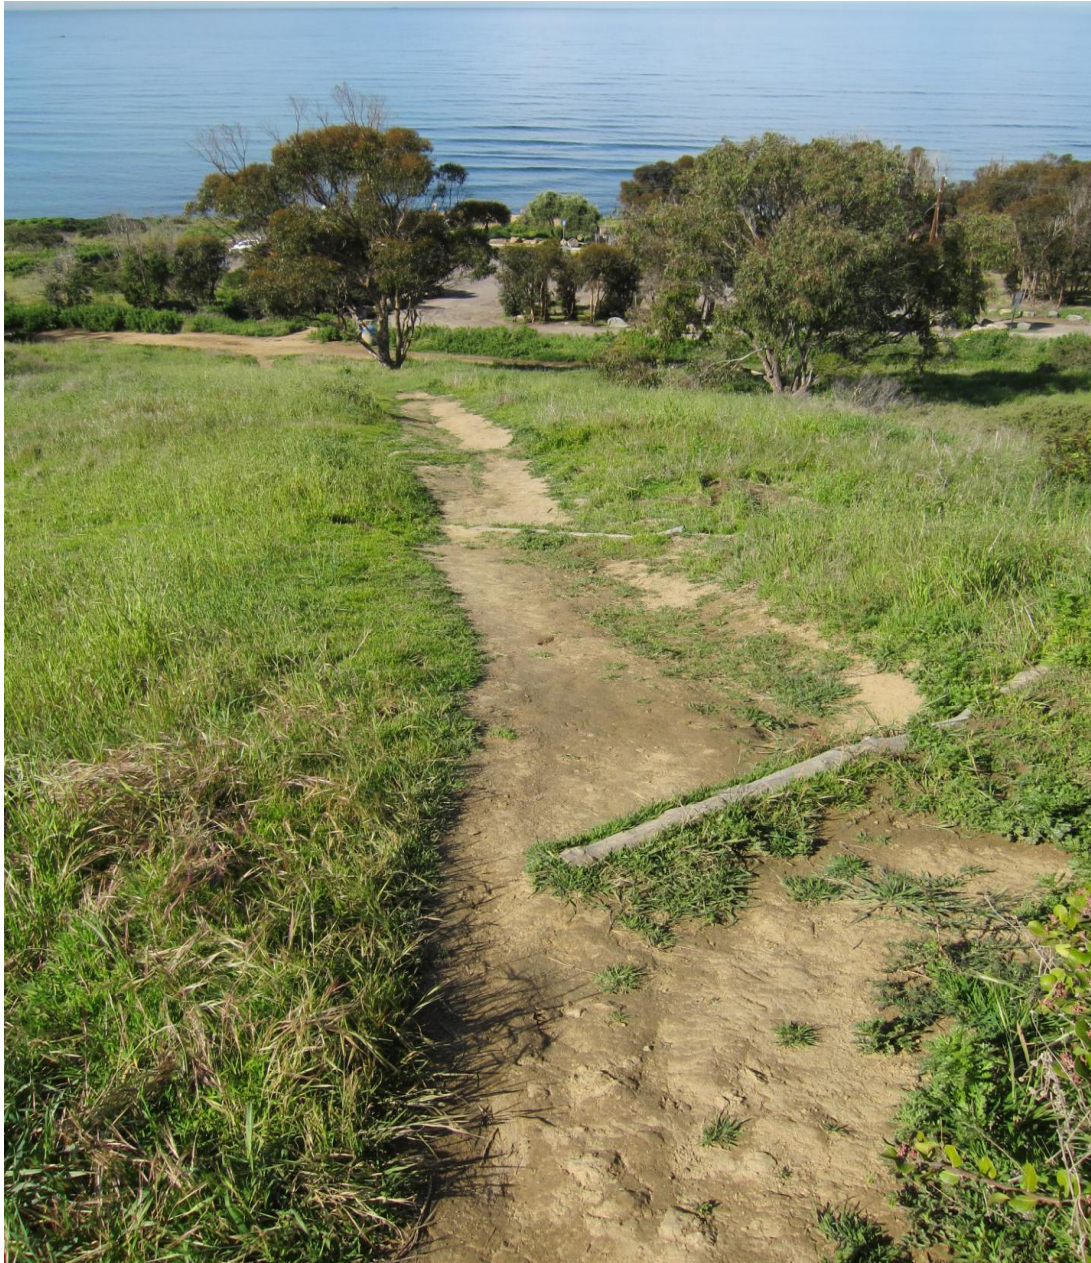
9. Runoff flows from source area B, and possibly runoff source area A, through Location 9 where it forms the erosion “trail” (shown in Figure 4) and an erosion gully before flowing, with its sediment load, into the Lower Parking Lot. A large erosion gully (see Figure 5) was formed as well by this runoff. The sediment loads, as well as the scouring effects of this runoff, need to be accounted for in the design of the Multi-use trail. Methods to control this runoff need to be determined, because the City/Dudek Backbone system is not designed to capture this runoff until after it has caused considerable erosion and flows along what will be the Multi-use trail.

Figure 4. East west running watercourse in 2005; trail bars have been installed in an attempt to slow erosion.

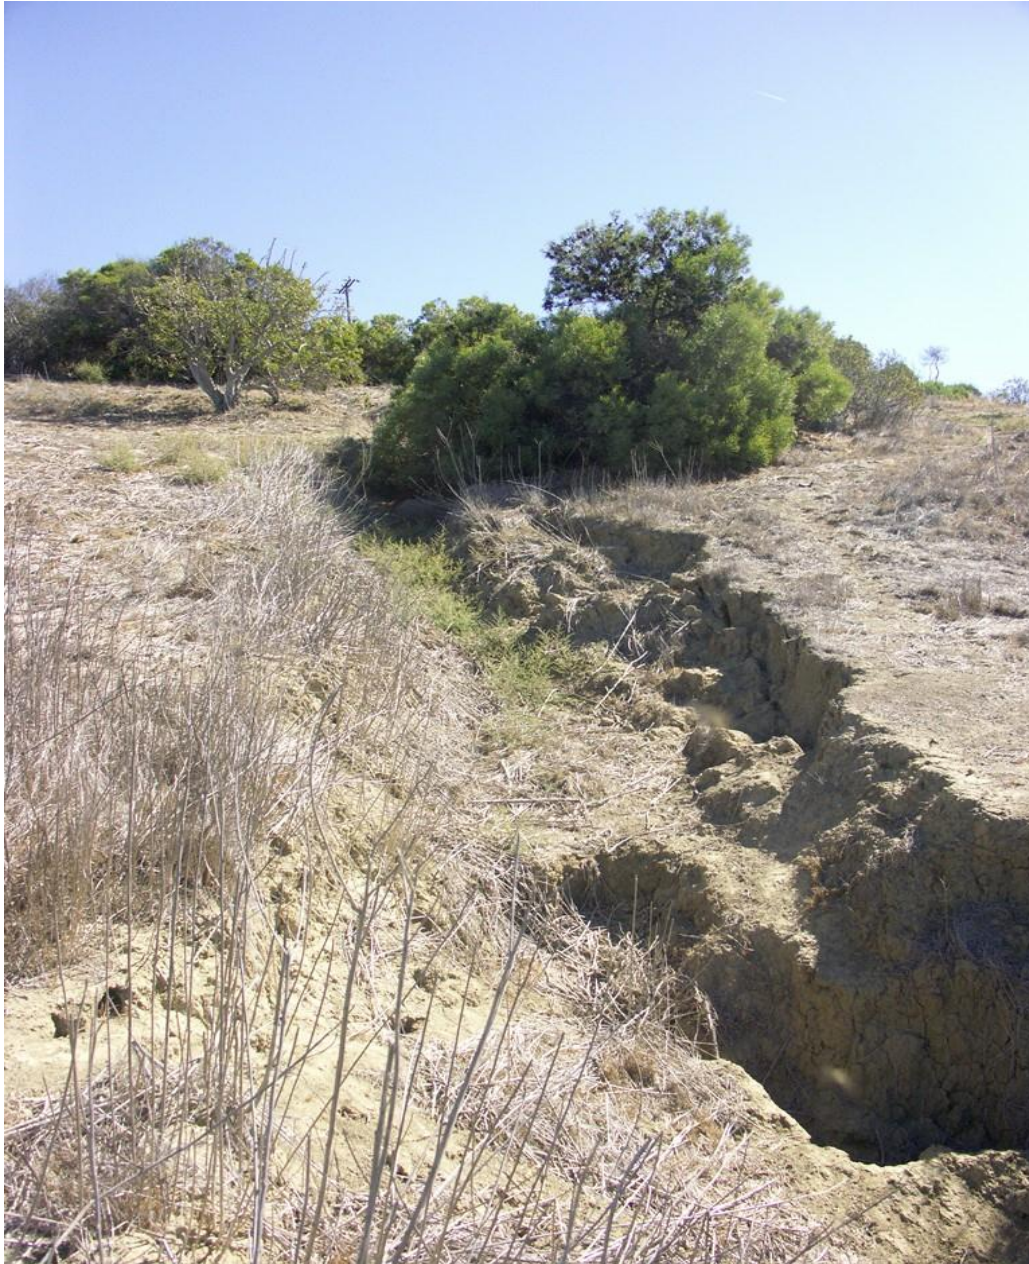
Figure 5. Erosion gully from Runoff Source B and possibly A, that is just above the Lower Parking Lot. It is located along watercourse 8 at 8B.

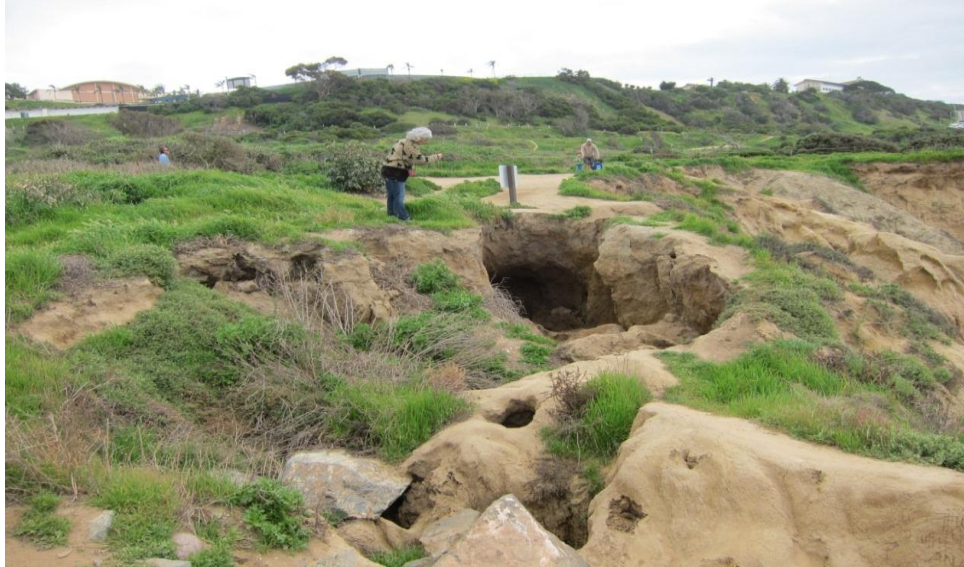
- 10.** Location 10, as well as Location 11 have major erosion gullies and sink holes due to runoff from southwest of the Lower Parking Lot (shown in Figure 5). These erosion features pose fall hazards to users of the primary and ADA trails. These gullies and sinkholes should be re-contoured when the runoff from the southern area of the parking lot is diverted to the Gunite swale and runoff from source area B is controlled.
- 11.** Same as above for Location 10.

Figure 6. Erosion and sinkholes caused by runoff from the Lower Parking Lot.

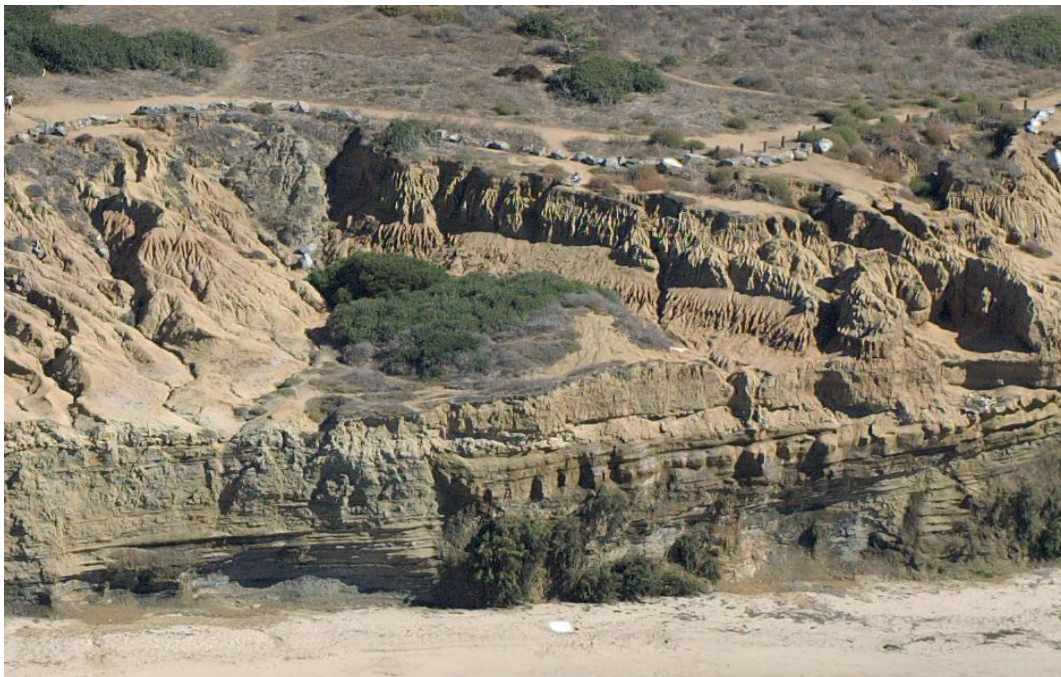
- 12.** It is hard to ascertain how much of the erosion damage at Location 12 (Figure 6) is due to runoff that flows from the Upper Parking Lot or runoff from the Western Loop Road. Runoff from the Upper Parking Lot can be controlled by the City/Dudek Backbone system or a system using media filters for treatment and storage. If this erosion is due to the Western Loop Road, it is possible that the PLNU interim mitigation measures for the Western Loop Road, implemented to satisfy Condition 38 of their CUP, or the City/Dudek Backbone system will eliminate the runoff creating these erosion features.

Figure 7. 2006 aerial photograph of Location 12 erosion.
